# Energy Audit

The Mann House

Mason, NH

### Introduction

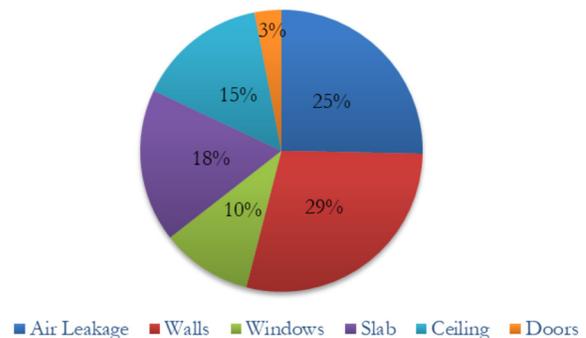
Mann House Envelope Losses

The pie chart shows the estimated break down of where heat loss occurs. The numbers reflect the percentage associated with each envelope component based on their assessed thermal performance.

It’s a tad more complicated in that physical materials are associated with **conductive** heat transfer, where as air leakage (ie the lack of a physical barrier) is associated with **convective** heat transfer. For example: it is estimated that 15% of the annual heat loss occurs through the insulation in the three ceiling planes. However, the ceiling plane is in large part responsible for convective heat loss which is represented in the 25% attributed to ‘air leakage’. In fact, windows, doors, and the foundation all contribute to convective losses. But air sealing the ceiling (highest) plane reduces the ‘stack’ or ‘chimney effect’ where cooler, outside is drawn in through gaps in the framing and window sashes, rises as it is heated, then exfiltrates through the ceiling and roof. This is also the primary cause of icicles and ice dams as the heated air warms the underside of the roof sheathing, melts snow, which then drains down to the eave and freezes when exposed to air. from below. This is why the recommended energy saving measures focus on air sealing at the ceiling planes and targeted ‘gaps and cracks’ throughout the building. Improving insulation layers is also cost effective as well as a complimentary measure to establishing an air barrier at the ceiling plane.

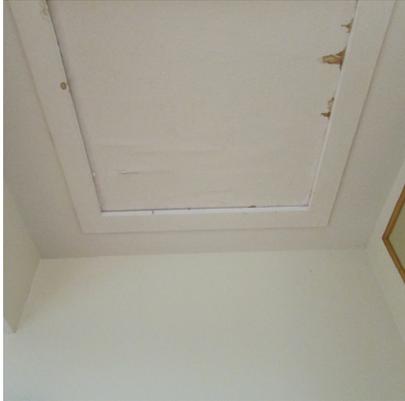
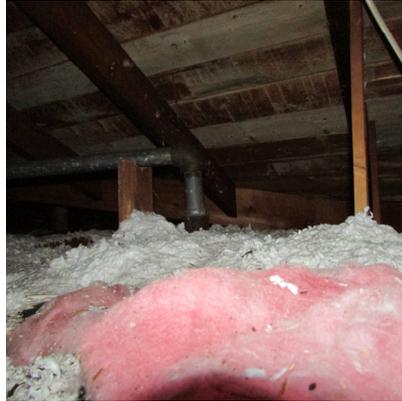
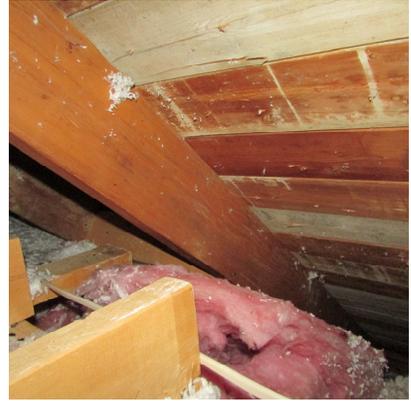
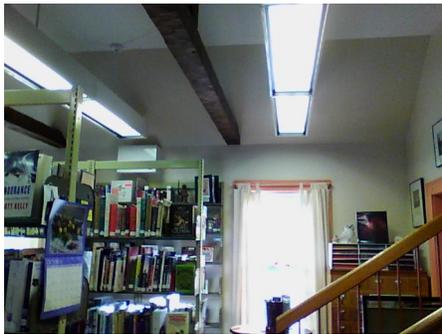
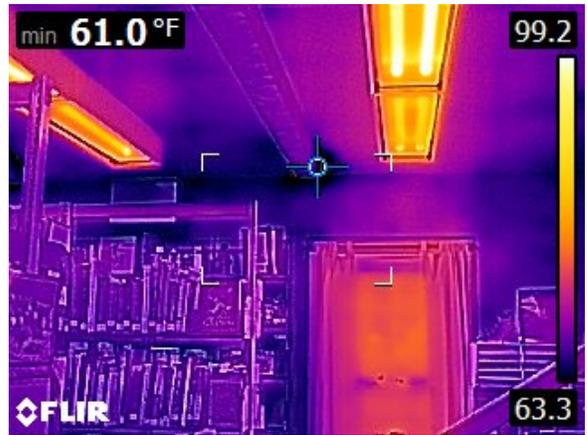
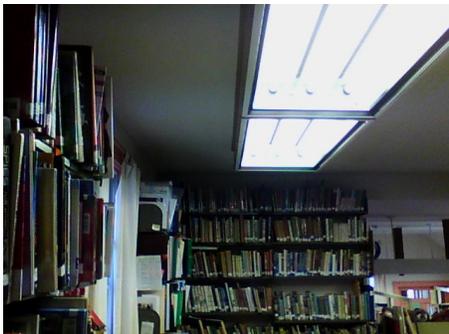
### ESM #1: Junior and Adult Library

There is a lot of insulating material above the ceiling, however there are signs of rodent activity and pockets or voids suggesting diminished performance. More significantly, slopes are largely uninsulated and the perimeter lacks a continuous air barrier. Recommended package: Remove all material, air seal all penetrations and install and foam seal Accuvents in the slopes, then blow in 16" cellulose. Insulate and seal hatch. Air seal the gaps between drywall and beams on the interior side. Weather-strip doors and windows. Additional benefits: the desk area will be warmer without needing space heater.

Thermographic images depict differences in surface temperatures. Dark areas are cooler surfaces indicating, in this case, areas of greater heat loss.

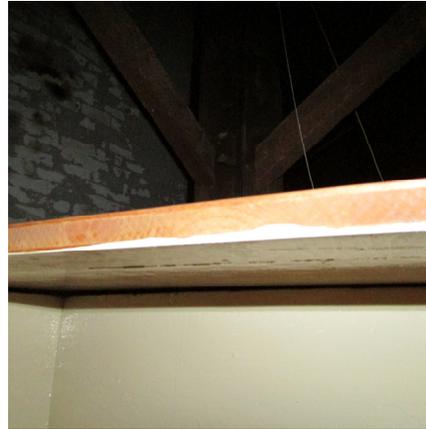
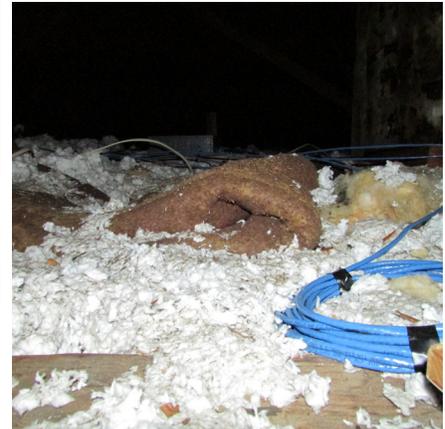
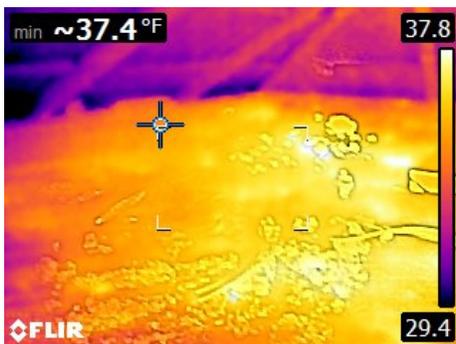
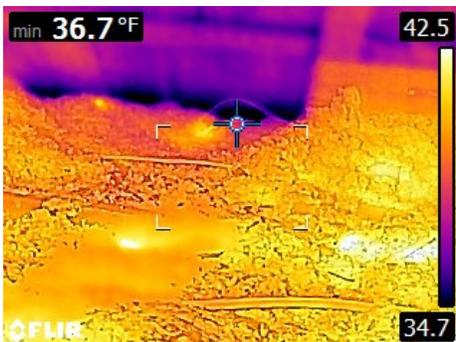
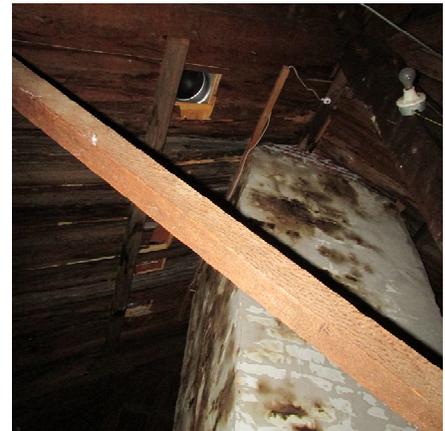
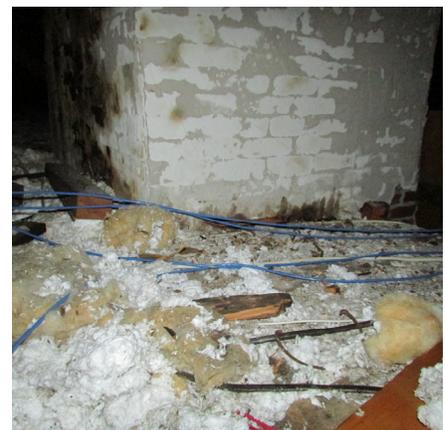
### ESM #2: Mann House Ceiling and Weather-stripping

In this case, taken from inside the cold attic, bright colors indicate heat loss from (semi) conditioned spaces below. Brightest spots may be a sign of wiring or where ceiling lights exist. (IR camera also takes digital images, but without a flash in the dark, they didn't come out)

The conditions and recommendations for the Main Attic are identical to the Library wing. Once the material has been removed, inspect all wiring and wood for damage or weaknesses. Also check chimney flashing and use rock wool and fire stop caulk or flashing where the chimney penetrates through the attic floor.

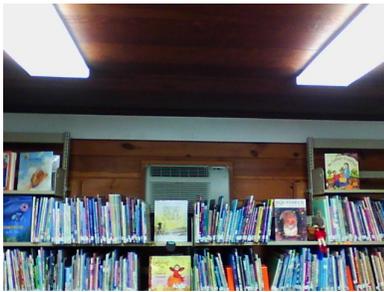
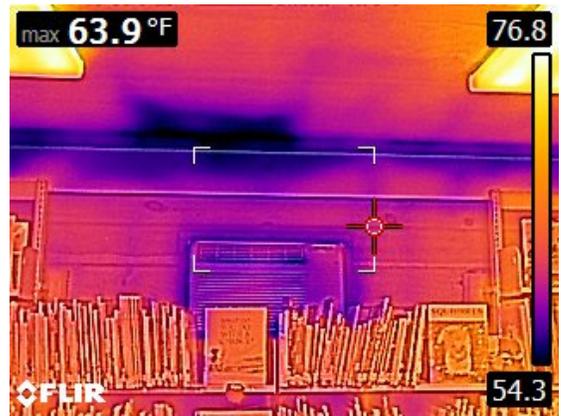
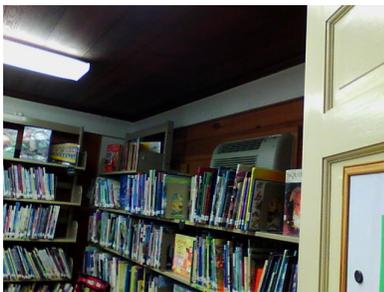
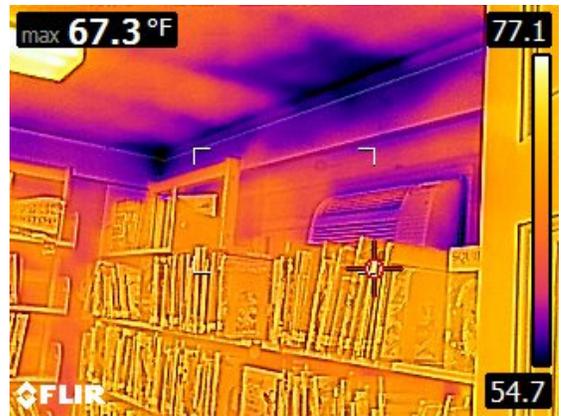
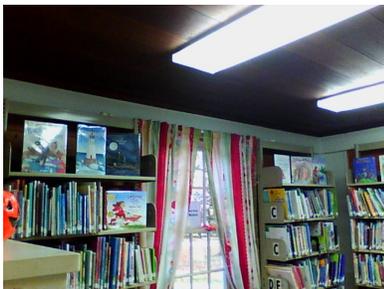
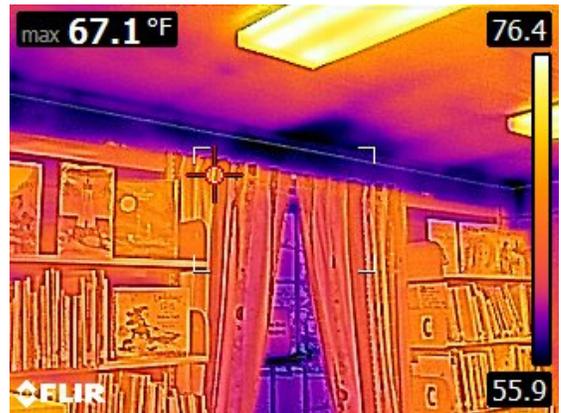
### ESM #3: Children's Room Ceiling and Weather-stripping

Insulation was not added above the ceiling in the 2008 renovation so it is not clear what exists above this ceiling plane and there is currently no access. There is no room to access under the roof from the outside so it is recommended that an access hatch be (carefully) cut into the ceiling and replaced and patched afterwards. Depending on what is discovered and ability to reach the perimeter, either air seal and blow cellulose as the other attics, or spray closed foam 6" on the underside of the roof sheathing. Note that if sheathing needs to be repaired or replaced, it should be done prior to spraying foam!

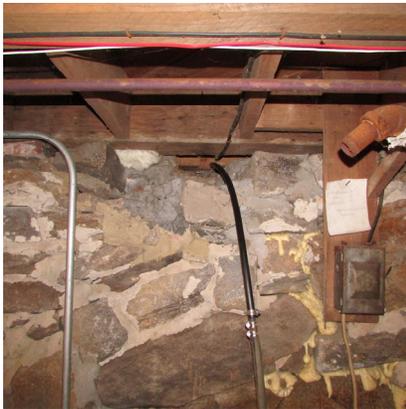
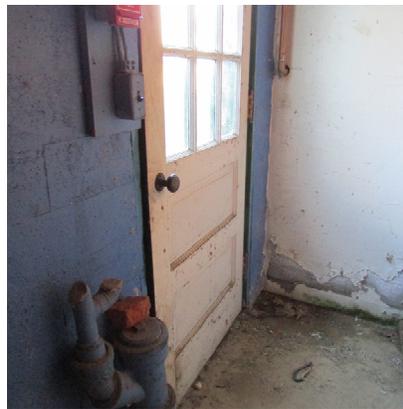
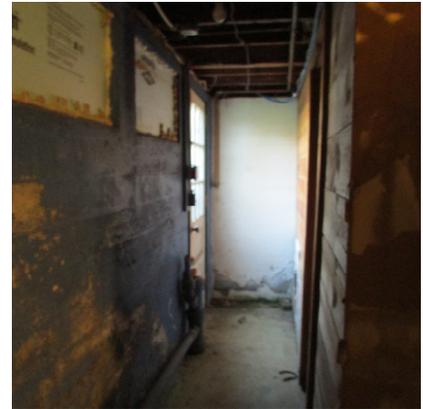
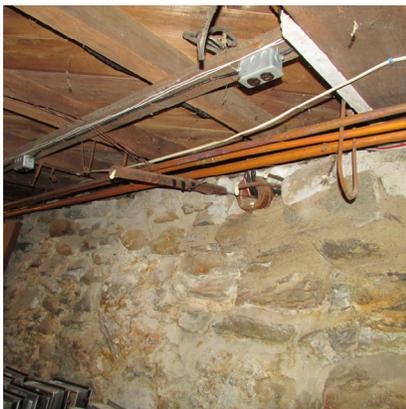
### ESM #4: Foundation Wall Insulation

Though listed as item #4, this ESM is key to both saving energy and managing moisture throughout the building. Closed cell spray foam is an appropriate option from a thermodynamic perspective, but if there is resistance from historical preservation goals, then applying a plastic liner and rock (mineral) wool batts may be an acceptable option. The goal is to create a continuous air and vapor barrier with a minimum of R10 insulating material on the below grade foundation walls. Above grade walls should receive an effective R20 and exterior doors should be weather-stripped and a rigid foam panel installed for winter. The sill beams, however, should be air sealed but not insulated as water can move up through the mortar via capillarity and the beams should not be deprived of heat or the ability to dry back to the interior. If there is new evidence of water intrusion, re-evaluate to determine if it can be stopped from the outside, or escorted more effectively to a sump hole with pump.

Once insulated, the heat loss from pipes and boiler jacket losses will maintain a warm and dry basement while reducing heating from the intentionally conditioned spaces above.

Water pipes should not be insulated now, as the heat loss into the basement serves an important purpose—and don't need to be insulated afterward walls, since the losses to the outside will be minimal.

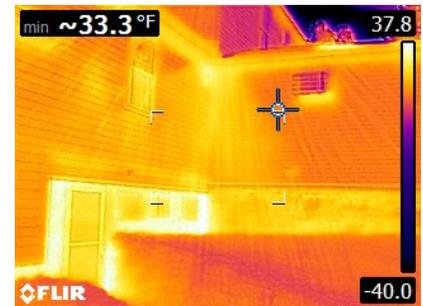
The crawlspace under the Library was not accessed, though it too may present a similar opportunity!

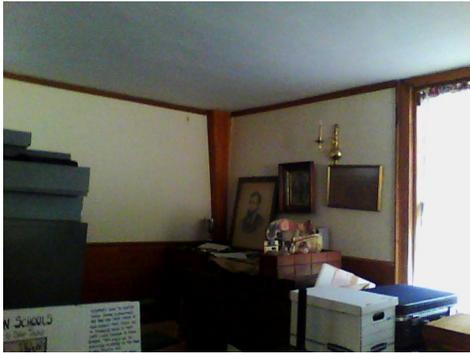
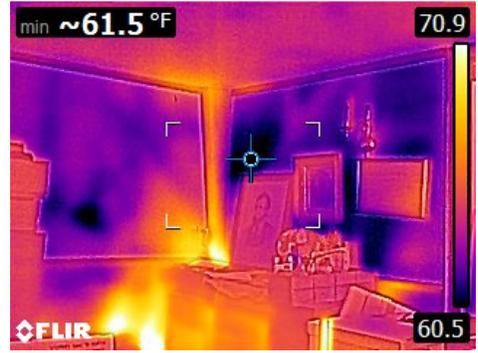
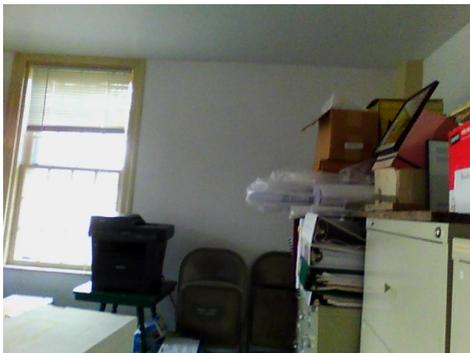
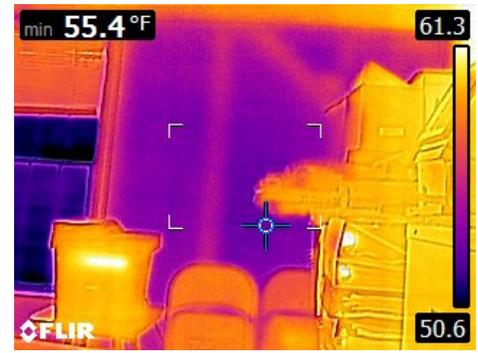
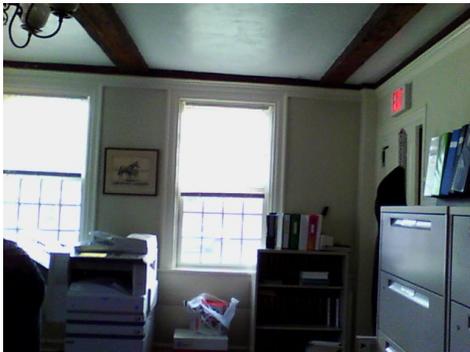
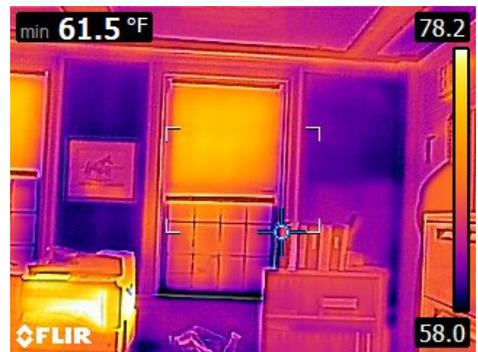
### ESM #5: Insulate Mann House Walls

The exterior walls of the original structure appear to have no insulation material, except possibly in the north wall of the 2nd floor—which would be unusual but anything’s possible.

Cellulose can be blown in from the outside by removing a clapboard and drilling a two inch hole into each cavity between stud bays. Corners will need more than one hole to access below cross framing.

In addition, clapboards at the band joists—between floors—can be removed and air sealed from the outside.

It should be noted that the building has survived these centuries (?) because a) it never caught on fire and b) it was able to dry if it got wet. Adding insulation to the walls changes the dynamics and will make the exterior sheathing colder, therefore increasing the risk of condensation. However, with four inch cavities, there will still be heat transfer and cellulose maintains excellent drying capacity. But it would also increase the importance of air sealing (reducing air transported vapor) and managing sources of vapor. Additional benefits include making interior wall surfaces warmer and therefore more comfortable for occupants!

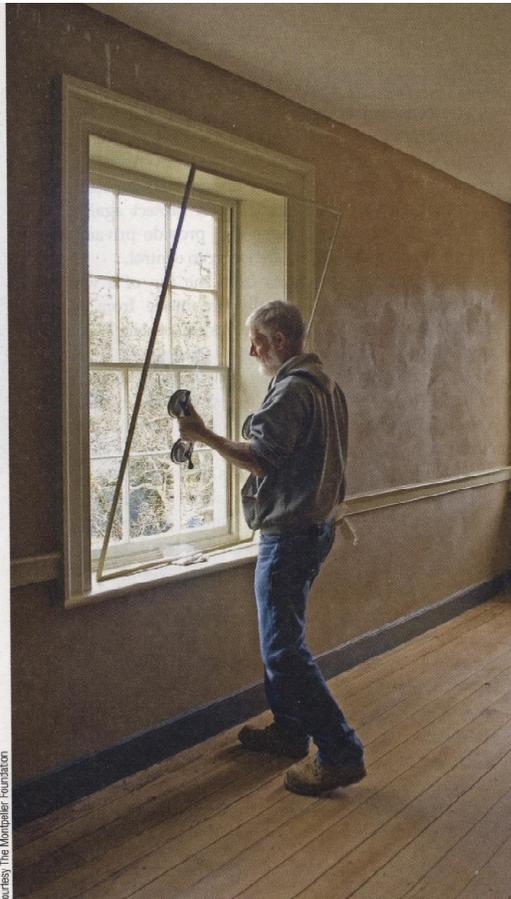
Interior glazing panels are an inexpensive way to boost a home’s energy performance without compromising its architectural integrity.

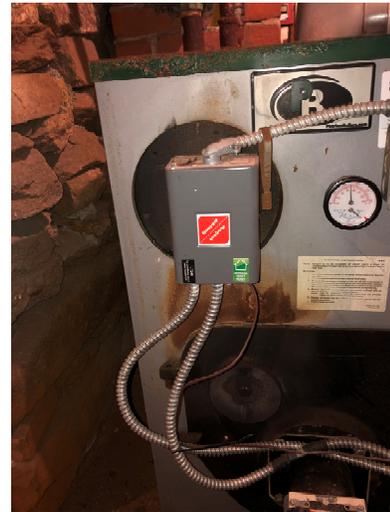
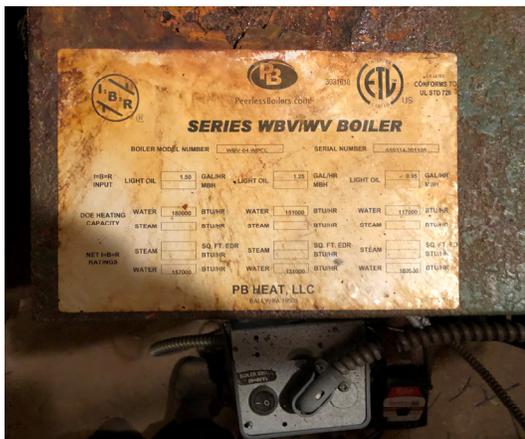
Peerless Boiler Model #WBV-04-WPCL

DOE Input 180KBtu/Hr

Output Capacity: 151KBtu/Hr

Based on the serial #659314-201105, the boiler was manufactured in May, 2011, however the presence of rust and flue gas leakage at the door make it look much older than its young 7 years!
